Radon mitigation in domestic properties and its health implications—a comparison between during-construction and post-construction radon reduction

Abstract

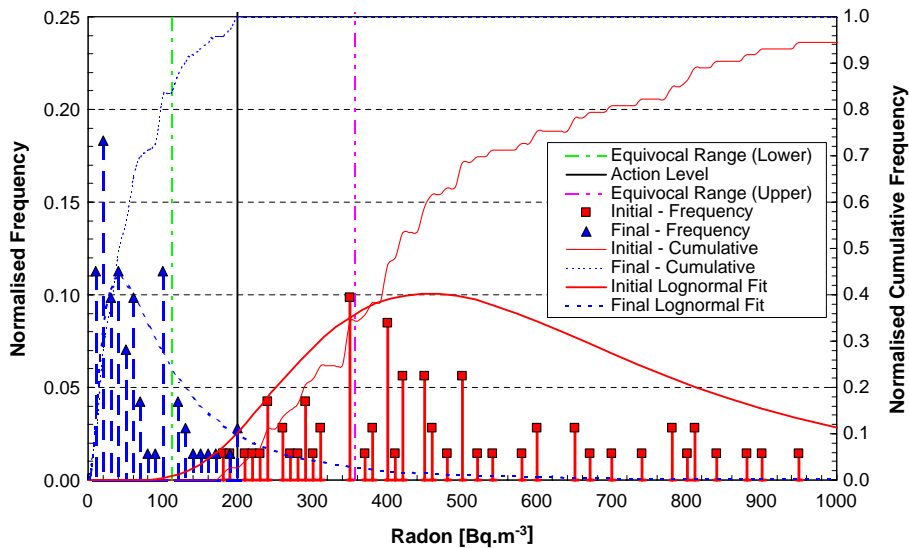
Fig. 2. Normalised distributions of radon levels in Post-Construction remediation series, with fitted lognormal distributions (broad-line plots) and normalised cumulative frequencies (narrow-line plots). Solid plots and bars (triangle markers): Before-Remediation distribution. Dashed plots and bars (square markers): Post-Remediation distribution. Vertical lines indicate lower (single chain-dashed) and upper (double chain-dashed) boundaries of the Equivocal Range, and the UK Action Level (solid line).

A total of 73 households, 7 of them (9.6%) situated in the NN6 9 postcode sector and of essentially the same construction and style, returned valid pre-remediation and post-remediation radon data. Fig. 2 shows the distributions of pre- and post-remediation radon concentrations, confirming the significant degrees of radon mitigation achieved by remediation. Also shown are the UK Action Level (200 Bq·m⁻³) and the upper and lower boundaries of the equivocal range (Phillips et al., 2004). In each case, the returned radon concentrations exhibited the lognormal distribution typical of sets of radon measurements (Gunby et al., 1993). Prior to remediation, virtually all of the returned results fell in the region above the Action Level, with a significant proportion of these falling above the upper boundary of the equivocal region. Following remediation, all of the properties concerned showed radon concentrations below the Action Level, with the majority being below the lower boundary of the equivocal region.

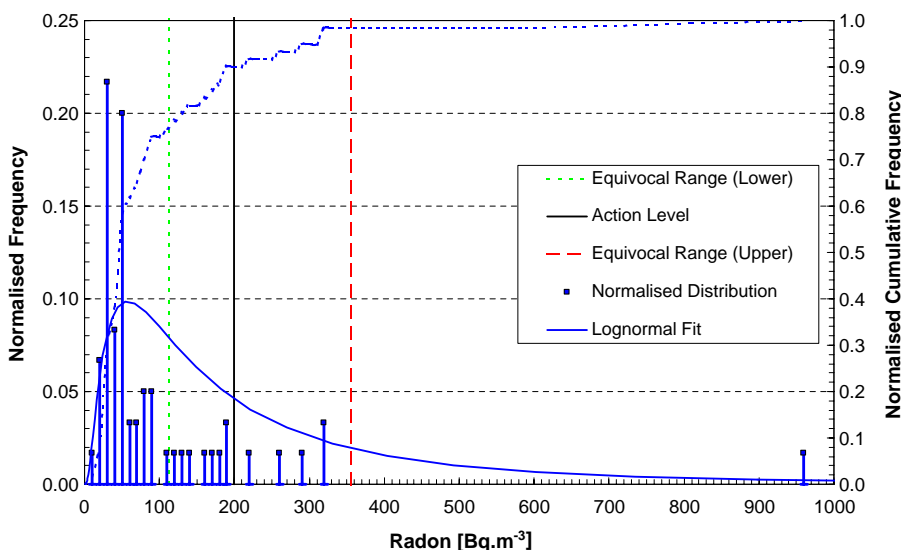
Fig. 3. Normalised distribution of radon levels in During-Construction Remediation Series, with fitted lognormal distribution and normalised cumulative frequency. Vertical lines indicate lower (single chain-dashed) and upper (double chain-dashed) boundaries of the Equivocal Range, and the UK Action Level (solid line).

Detectors were returned from a total of 68 dwellings in which radon mitigation was installed during construction, all situated in the NN6 9 postcode sector. Of these, 4 detectors were spoiled, leaving 64 usable results. Mean radon concentrations again exhibited a lognormal distribution, as shown in Fig. 3, and were significantly lower than those found in the unremediated houses in the same postcode sector (cf. Table 1). On the assumption that the pre-remediation radon concentrations returned by the latter provide a benchmark for the local area, the results provide convincing evidence that During-Construction radon reduction provides protection against the ingress of radon. Despite this, however, seven houses (11%) returned radon concentrations above the Action Level of 200 Bq·m⁻³. Overall, 47 (73%) of these houses exhibited radon concentrations below the lower boundary of the Equivocal Range, 112 Bq·m⁻³, and these can therefore be regarded as having concentrations definitively below the Action Level. Sixteen houses (25%) returned results within the equivocal range and would therefore, in practice, require to be repeated, while one house (1.6%) returned a radon concentration above the upper bound of the Equivocal Range, and therefore definitely in excess of the Action Level.

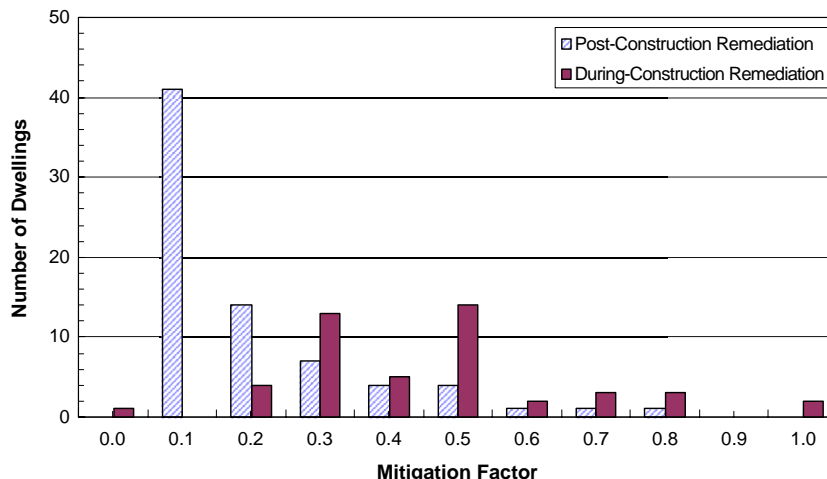
Fig. 4. Effectiveness of mitigation achieved by During-Construction and Post-Construction techniques (adopting the mean radon concentration for the NN6 9 postcode sector as reference). Hatched bars: Post-Construction Remediation. Solid Bars: During-Construction Remediation.

Fig. 4 shows the distribution of mitigation factors achieved in the During-Construction set, based on the assumption of a $120 \text{ Bq}\cdot\text{m}^{-3}$ reference concentration. The distribution is bimodal, with maxima around 0.3 and 0.5, and, at the assumed reference concentration, the overall mitigation levels achieved are generally lower than those resulting from Post-Construction remediation. Use of a higher or lower reference concentration merely shifts the plot towards lower or higher mitigation factors respectively, but does not affect the form of the distribution.

As shown in Fig. 4 the distributions of mitigation factors achieved by During-Construction and Post-Construction radon reduction differ markedly. Post-Construction remediation is characterised by a high incidence of good mitigation outcomes, with more than 75% of the sample exhibiting mitigation factors of 0.2 or better, decreasing monotonically at poorer mitigation factors. In contrast, During-Construction radon reduction is characterised by a bi-modal behaviour, with approximately equal maxima in the regions of 0.3 and 0.5. One possible explanation for this is that the data reflects the existence of two distributions of mitigation efficiency in the population, one deriving from well-installed membranes, exhibiting an intrinsic mitigation factor around 0.3, and the other representing a defective membrane population, affording only 0.5 mitigation. Arafa (2002) reports the permeability constant and permeability of $375 \mu\text{m}$ polythene to be $3.6 \times 10^{-12} \text{ m}^2\cdot\text{s}^{-2}$ and 0.123, respectively, a figure which, while not in very good agreement, is not incompatible with the above suggestion. Alternatively, however, it must be remembered that detailed analysis of the During-Construction data set is hindered by the intrinsic absence of absolute reference data for each house in the sample. While derivation of an imputed mean from measurements of other properties in the locality offers a reasonable course of action, it suffers from the fact that much of the distributional information in the reference sample is lost in the statistical processing, a situation that may well be reflected in the form of the observed mitigation distribution.
